Historic Furnishings Report

Ship BALCLUTHA

San Francisco Maritime National Historical Park

Draft by Ted Miles 1994 and updates

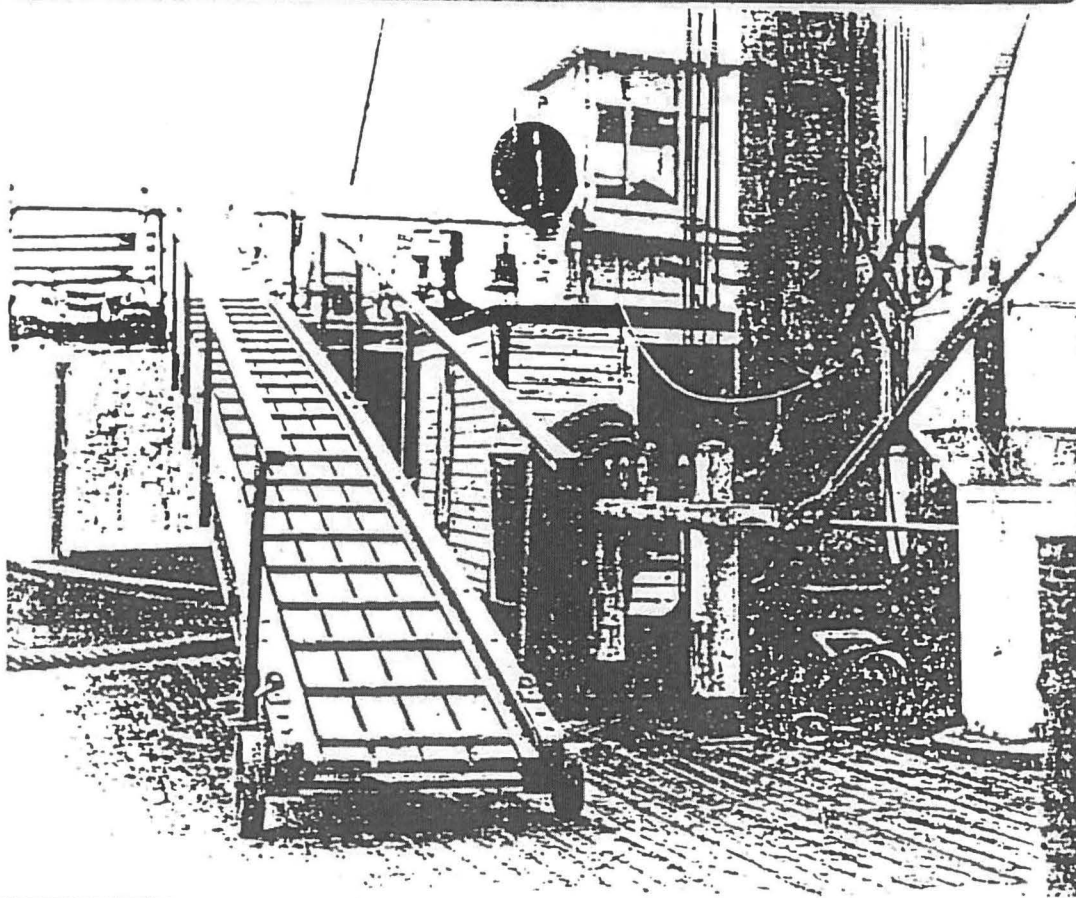
Note vent, Booby hatch with sliding door,
large vent with Liverpool type head

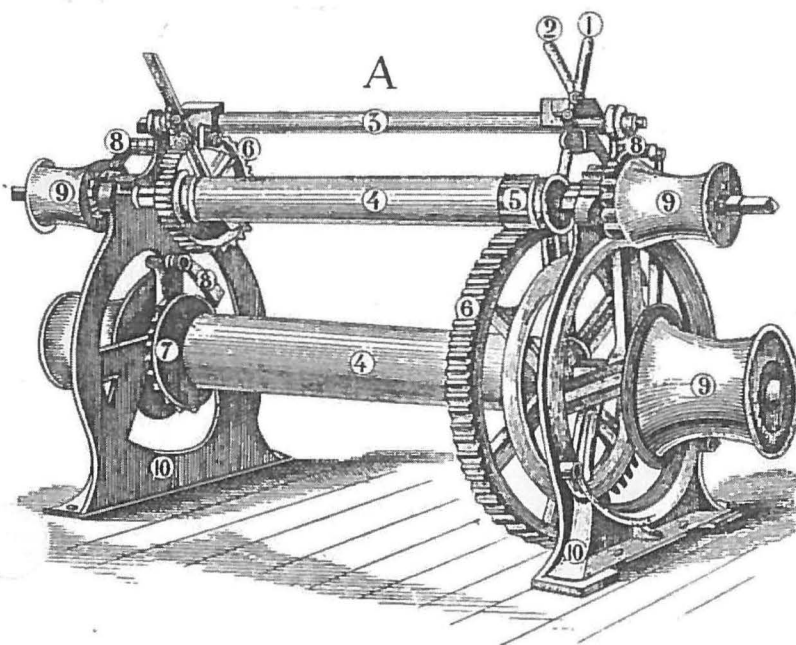
A. Winch.

- 1 Clutch-lever.
- 2 Brake.
- 3 Tie-rod.
- 4 Barrels.
- 5 Pinion.
- 6 Spur-wheels (*).
- 7 Ratchet-wheel.
- 8 Pawls; Palls.
- 9 Warping-ends.
- 10 Framing of winch.

One of the most interesting things that is missing from the Balclutha and most of the other surviving Cape Horn square riggers are the cargo winches. The Specifications describe them as, "Winches-- One double purchase winch at fore hatch and triple purchase winch at main hatch all to be fitted down on teak soles with iron plate riveted to the beams and fastened with strong

Here is an interesting opportunity to do a detailed study on just exactly they had here. Unfortunately the Connell letters do not mention what company made the machinery. However they were simply known as "patent winches" there were many foundries that made such equipment. An early example from the Cutty Sark is shown

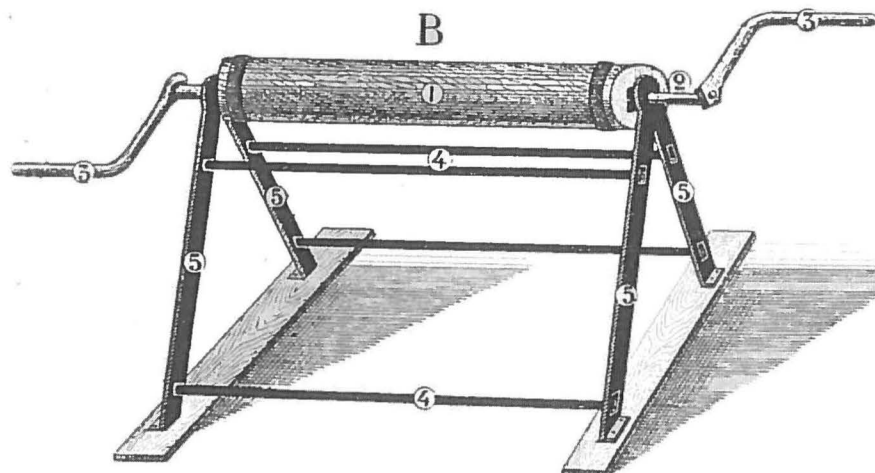
B. Crab-winch.

- 1 Barrel.
- 2 Barrel-shaft.
- 3 Handles; Winch-handles.
- 4 Tie-rods.
- 5 Standards of winch; Framing of winch.

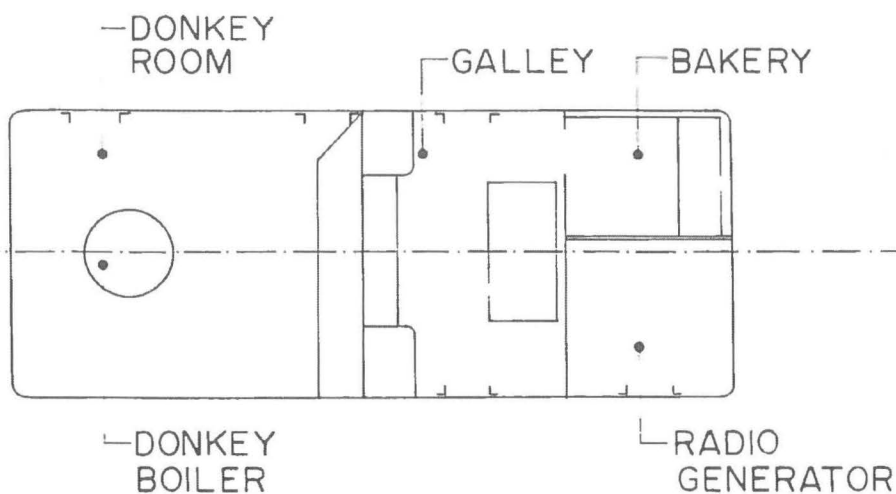
Part I no 2

MIDSHIP HOUSE

Alaska Packers 1922
as redrawn by HABS/HAPER

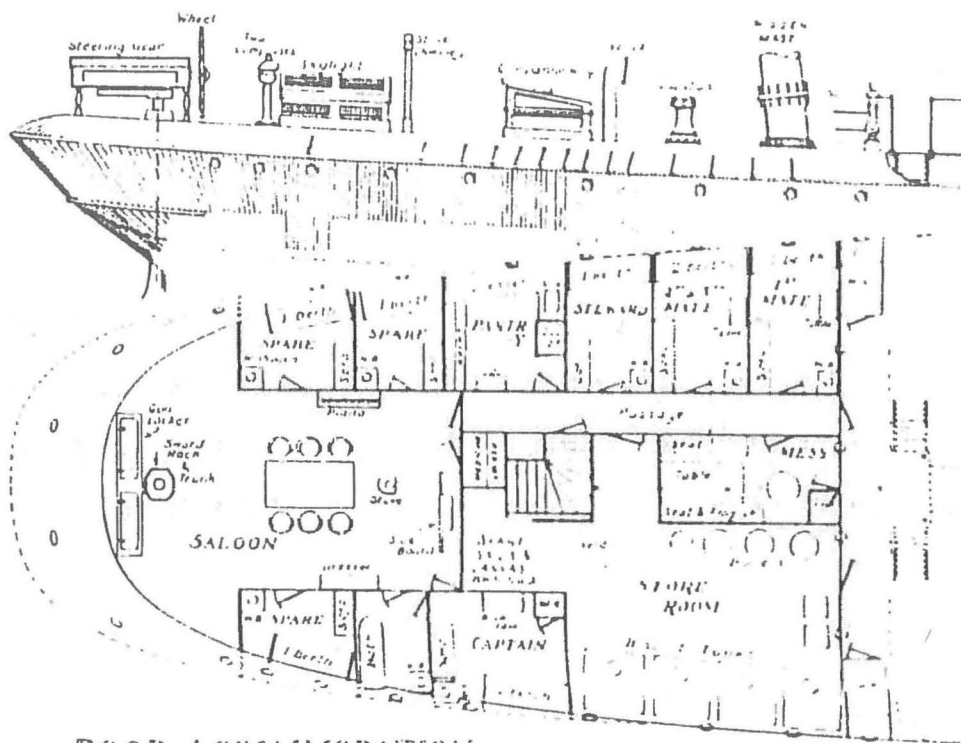
POOP ACCOMMODATION
SHIP WAVERTREE
George F Campbell - 1967

There are no known photographs of Balclutha's interior taken before the 1930's which is after her historic period but there are other photos taken aboard similar ships. Some of them are from ships built in the Charles Connell shipyard. They will be discussed as part of this study. Details of other ships built in Great Britain around the same time will also be considered. The interiors of British ships were surprisingly similar in this period. The decision has been made to restore the ship to the British period so the aim of this discussion is to follow British style and to follow Victorian practice in each case. The recent discovery of the Specifications and Outfit of the Balclutha has

been of immense value in understanding the contents of the poop accommodations aboard the ship.

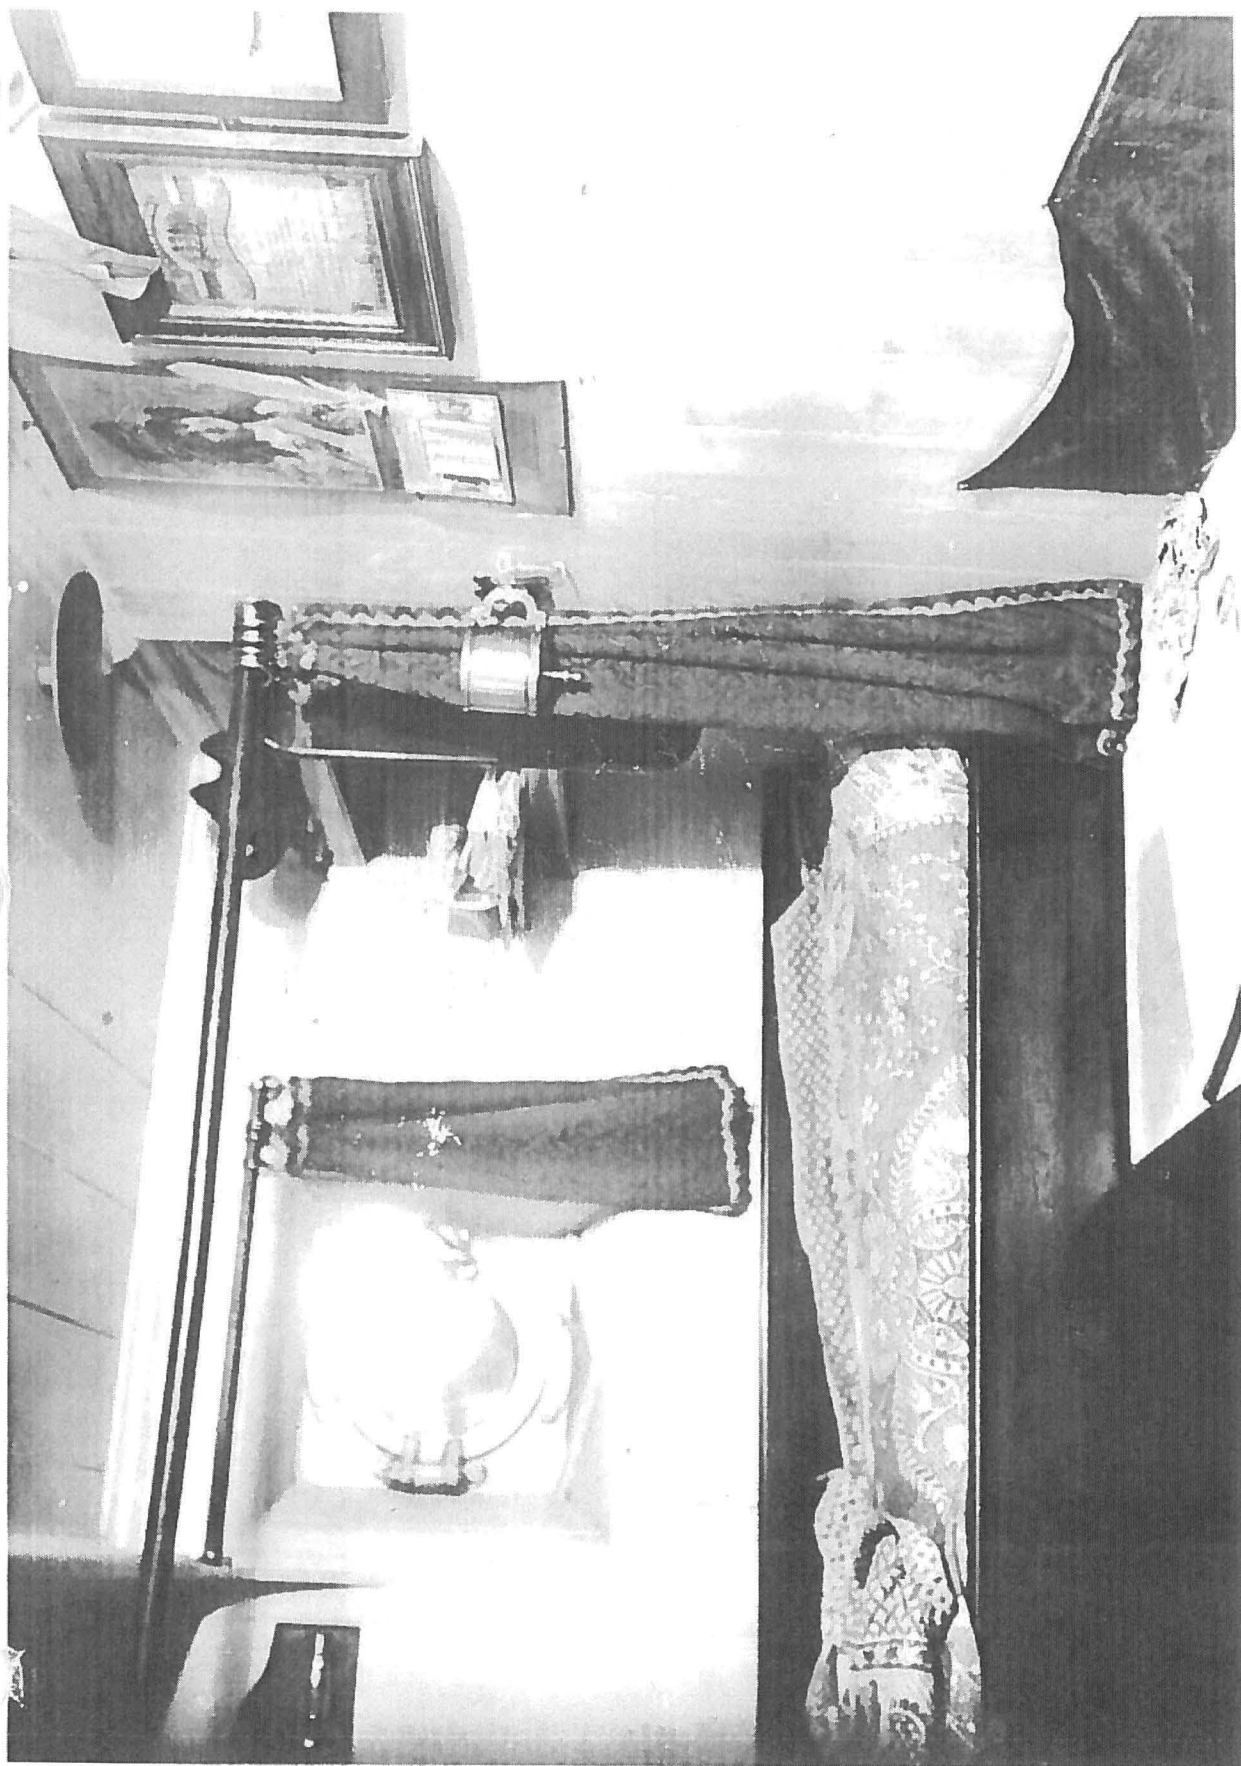
Mystic Seaport Photo
P92-016.2n
4 bk Hawaiian Isles
May 26, 1904
Mates Cabin

There is a photo (P92.016.2n) showing the Mate's room aboard the HAWAIIAN ISLES, a vessel built by the Charles Connell yard in 1892, just a few years after the Balclutha. From it we can see that the wide tongue and groove used to build the walls matches the style in our ship, that the walls are painted and the bunk

and other furniture are varnished hardwood. And there is a desk on the forward wall of the room. It was normal practice to build drawers under the bunk and to have a hanging locker in the room. The specifications say, "Captain and officers rooms and staterooms to be fitted with sleeping births, wash basins, toilet racks mirrors and brass hooks. Mates room to have desk fitted." They also call for the floors of officer's rooms and lobby to be covered with best quality linoleum.

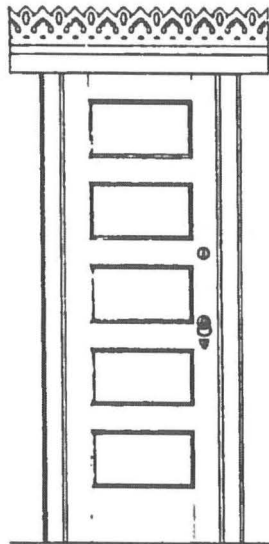
Wooden Grillwork Detail Scale is 1/2 Actual Size

Grillwork opposite pantry in officer's quarters (depicted here) is slightly smaller than grillwork in shelter deck

Exterior Elevation

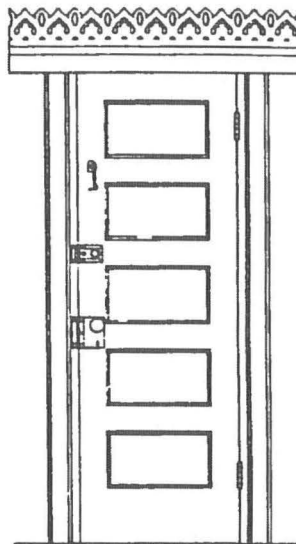
Interior Elevation

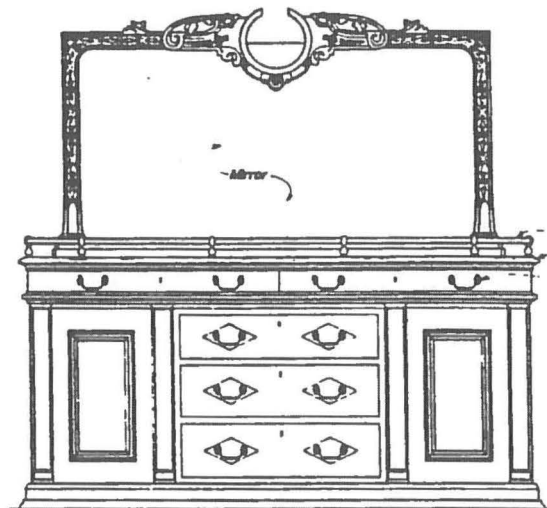
Front Elevation

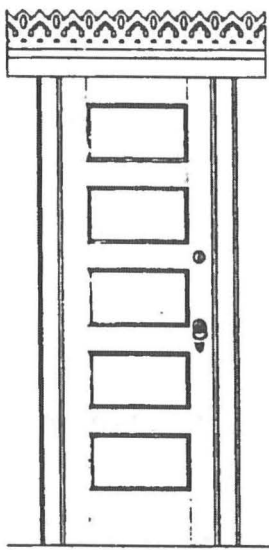
Wooden Grillwork Detail Scale is 1/2 Actual Size

Grillwork opposite pantry in officer's quarters (depicted here) is slightly smaller than grillwork in shelter deck

Exterior Elevation

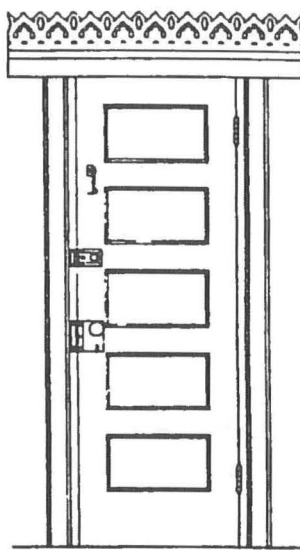
Interior Elevation

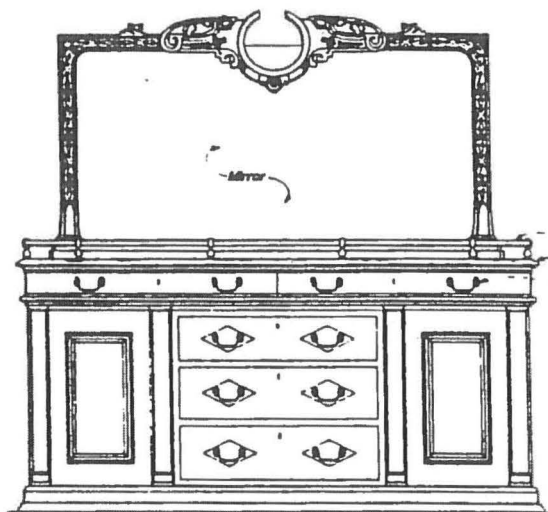
Front Elevation
